Damaged Fall Protection

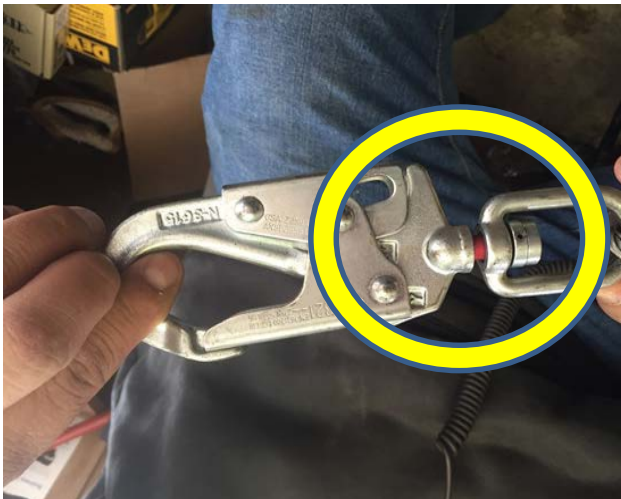
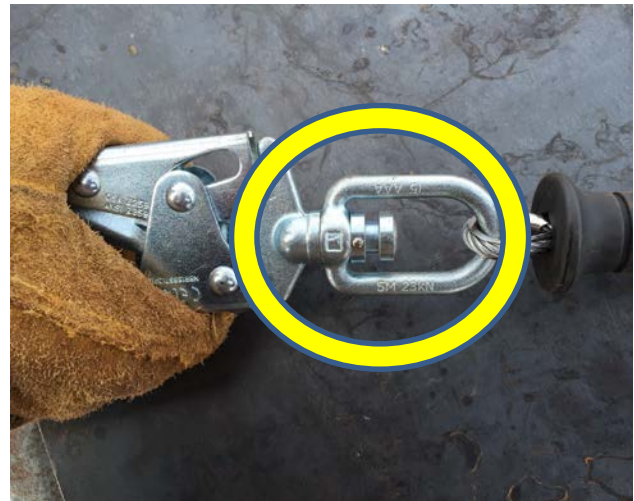
Incident Description: On 1-19-16 during a pre use inspection of a Self-Retracting Lifeline (SRL) an employee noticed the **RED** impact indicator on the snap hook swivel connection. The **RED** color band indicates that this SRL had been subject to impact loading typical of a fall. The jobsite had not experienced a fall and was unsure of when the system had been shock loaded. When the exposed color band **RED** is showing (as seen on the left) the SRL must be removed from service and returned to the manufacture for service and/or repair. All other SRL's on this jobsite were inspected and verified to be in good working condition.

- ✓ Always conduct a pre use inspection on ALL fall protection equipment.
- ✓ Never assume equipment is "Ready" for use.
- ✓ If damage is found immediately remove it from service, tag it for repair and notify your supervisor.
