Falling Object – LN25 Handle Fail

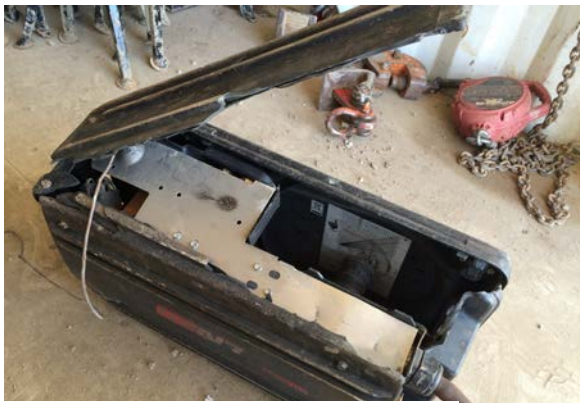
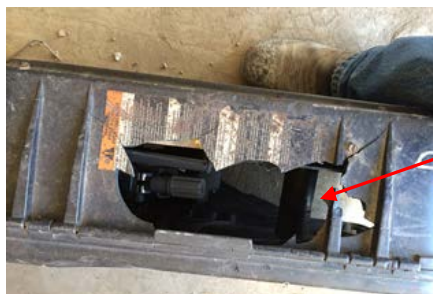
Handle Assembly

Incident Description: On 5-5-2016 employees were hoisting an LN25 with a rope. The rope was attached to the suitcase handle on the LN25. When the welder was approximately $\frac{3}{4}$ of the way up (30 feet) the handle broke and the machine fell to the tank floor. The LN25 had a full roll of weld wire installed adding to the weight the welder. No injuries were sustained from this incident.

- ✓ An inspection was completed the LN25 on 5-2-16 but the welder was not inspected the day of the incident.
- ✓ Cracks were observed around the handle after the incident that would indicate the case was damaged before the welder was dropped.
- ✓ The welder had a full spool of wire.

- ✓ The handle is intended to be primarily used for short term carrying of the welder.
- ✓ The lifting handle is not intended for overhead lifting.
- ✓ Anytime a tool or component will be lifted overhead care must be taken to inspect and verify the equipment prior to lifting.
