Falling Object – Incorrect Tethering

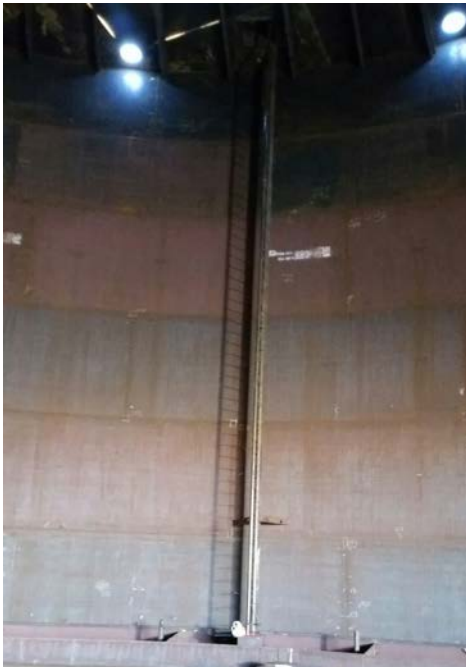
Incident Description: On 1/29/2015, Two GBI employees were removing a 3 foot by 3 foot section of roof plate for a ladder/gauge pole access door. The employees welded a nut onto the sheet and secured the sheet with a rope to the handrail. Upon making the final cut, the sheet dropped into the opening and the rope was cut by the sharp edge around the cutout. This caused the sheet to fall approximately 50 feet to the deck below. Before work started the supervisor informed the entire crew of the activities and had cleared and protected the area below the work.

- ✓ The wrong method was used to secure the sheet.
- ✓ Never use nylon straps or rope around sharp/hot surfaces.
- ✓ Confirm attachment points will hold the intended loads.
- ✓ Anytime overhead work is conducted verify the area below is properly barricaded and no one is in harm's way.

- ✓ The Job Hazard Analysis (JHA) should address the appropriate material when tethering or supporting a load.
- ✓ Use of a crane to support or suspend the load should be considered with larger items.
